# Township of McGarry, Ontario

### Unmanageable leakage from water and wastewater conveyance networks

### Comprehensive services: inspection, design, construction, funding applications and reporting

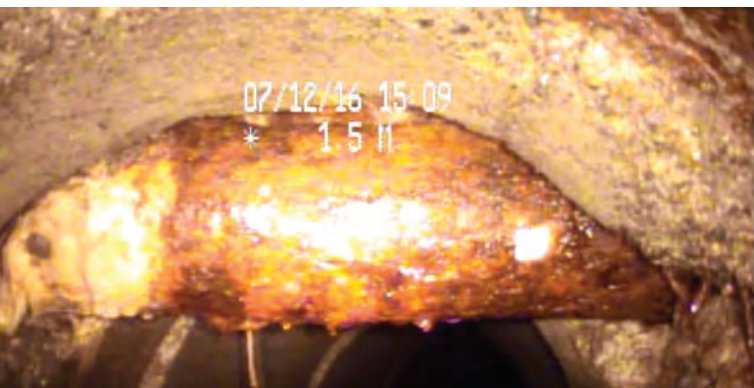
CCTV inspection showed several areas of concern in the sewers, including sections where water lines passed right through the sewer.

"About 13 percent of the sewer was in condition five; the worst possible," Semanuik says. "We found several holes, areas where root masses had penetrated the sewer, and a watermain that was crossing right through the sewer. In another section the water and sewer lines were so badly deteriorated, water was gushing directly from the leaking main into the sewer."
