Virginiatown-Kearns McGarry Township, Ontario

Unmanageable leakage from water and wastewater conveyance networks

Comprehensive services: inspection, design, construction, funding applications and reporting

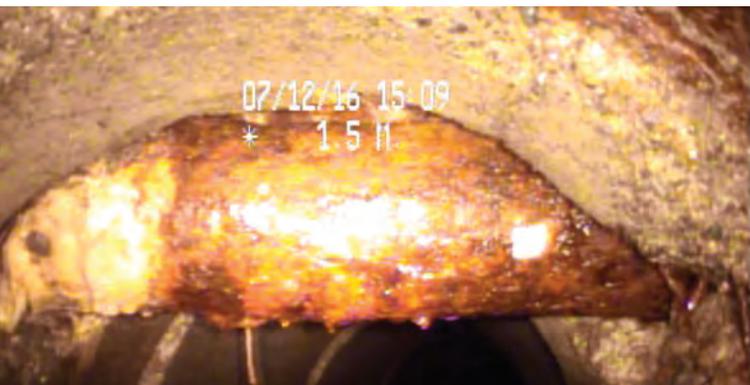
CCTV inspection showed several areas of concern in the sewers, including sections where water lines passed right through the sewer.

"About 13 percent of the sewer was in condition five; the worst possible," Semanuik says. "We found several holes, areas where root masses had penetrated the sewer, and a watermain that was crossing right through the sewer. In another section the water and sewer lines were so badly deteriorated, water was gushing directly from the leaking main into the sewer."

For the wastewater pipelines, Semanuik and her team worked with the Township to prioritize the repairs and planned four replacement projects for the most serious areas. Remaining funds from the initial grant were used for some repair work and OCWA led the preparation of new grant applications for the other repairs.

Two major repairs to the wastewater lines were completed in October 2016, which reduced average daily flows to the treatment plant by at least 25 percent.
