Partnering with First Nations

Moose Cree First Nation

Moose Factory Island, Ontario

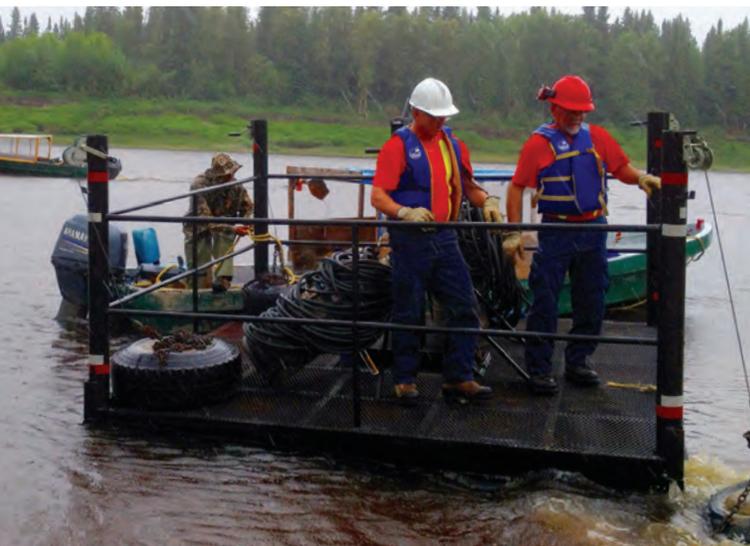
That same year, during the spring thaw, heavy ice break up in the tidally influenced Moose River destroyed a significant portion of the plant's water intake, causing a crisis situation as the community lost its water supply.

In early 2006, Health Canada contracted OCWA to assess the plant and develop a plan to restore to full operational status. OCWA staff took action to upgrade components such as pumps, chemical feed equipment and monitoring equipment.

OCWA also worked with Health Canada and Indigenous and Northern Affairs Canada (INAC) to obtain funding for a Supervisory Control and Data Acquisition (SCADA) system. The repairs restored the automated functions of the plant such as flow control, chemical dosing, monitoring, performance data logging and alarms.
